Subject: Dam Safety Inspection Reports  
York Creek WS SCS Site 6 Dam – TX01605  
York Creek WS SCS Site 11 Dam – TX01603

### **DAM SAFETY INSPECTION REPORT**

INVENTORY No.: TX01605

DAM: York Creek WS SCS Site 6 Dam

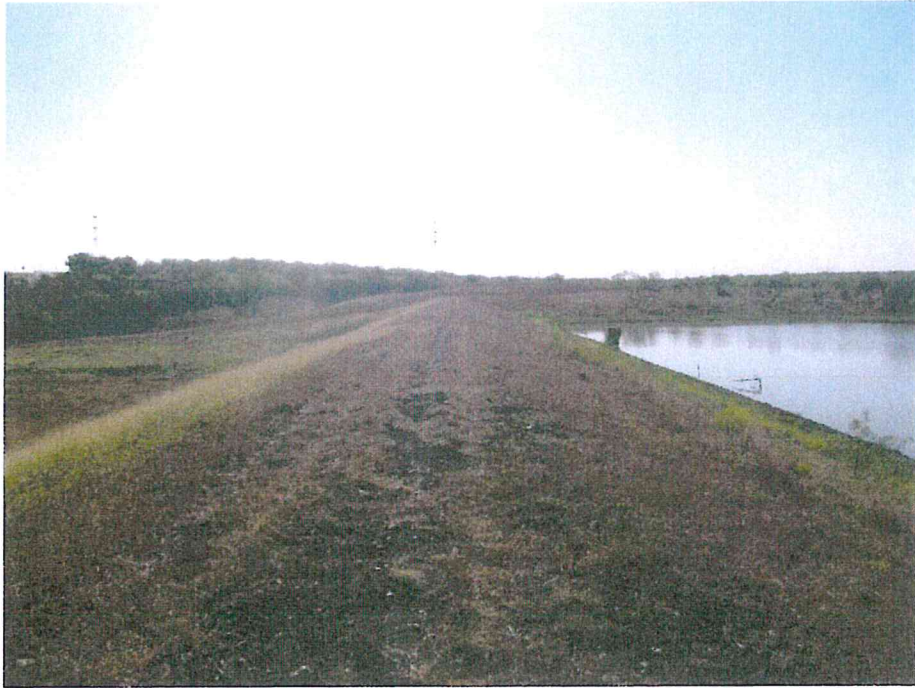
- The 14-foot wide crest of the dam was mainly level with good grass coverage, however, minor rutting and bare spots were noted due to vehicle and animal traffic.
- The crest was found to be in good condition.
- See photographs 1 and 2.

Photograph 1. Crest looking right. Note rutting and bare spots.

3. The following deficiencies need to be added to your O&M plan:
  - a. Monitor on a regular basis the bare spots and rutting on the crest until a grazing plan is implemented and repairs are made. Additionally, limit vehicle traffic on the crest during wet conditions.

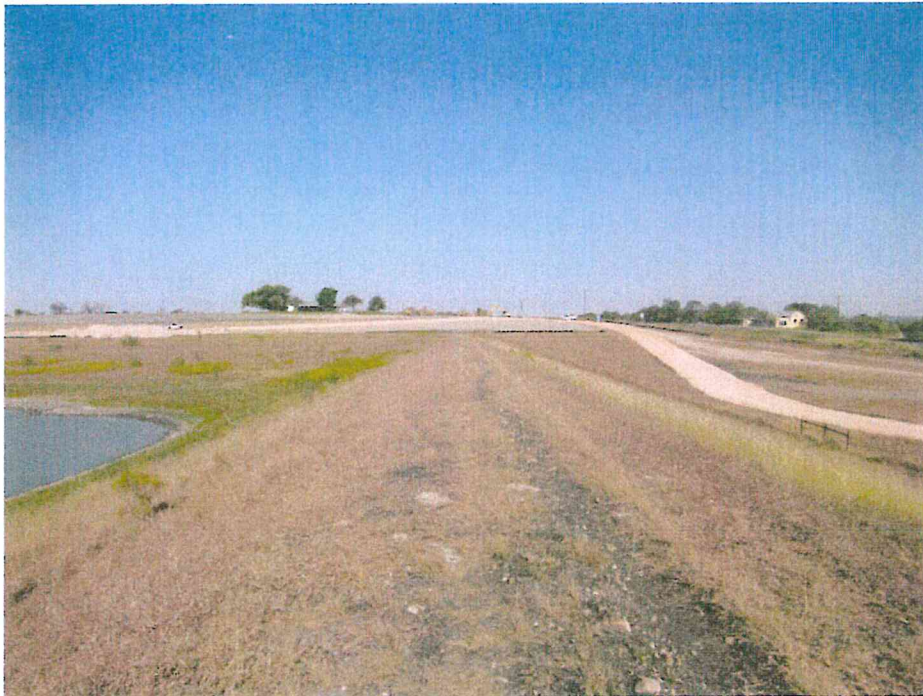
Photograph 2. Crest looking left. Note rutting and bare spots.

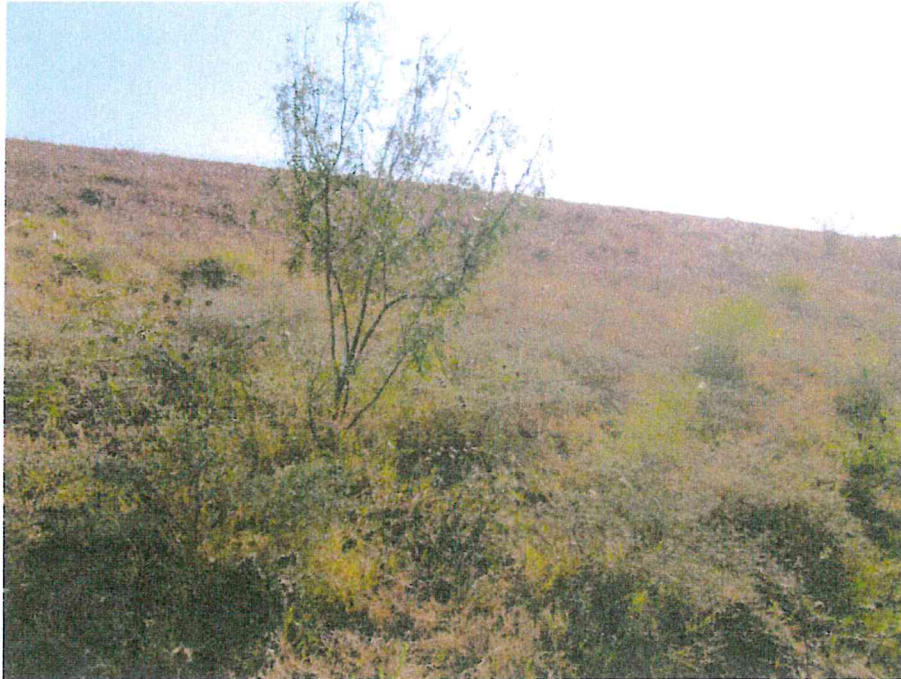
- The 2.5 horizontal to 1 vertical [2.5H:1V] upstream slope of the earthen embankment contained several saplings and benching which measured up to 2 feet deep. The 2017 report notes benching was measured up to 6 inches deep in several areas along the shoreline. The benching is progressing. The grass coverage was good.
- The fence at the left end of the upstream slope has a hole.
- The upstream slope was found to be in fair condition.
- See photographs 3, 4, 5, and 6.

Photograph 3. Upstream slope with saplings.

- b. For any larger/mature trees immediately adjacent to conduits and/or concrete structures (headwall, training walls, etc.), it may be preferred to cut the tree and leave the stump in place, if removal of the rootball would cause damage/movement to the conduit, concrete, etc. Any remaining stump(s) should be treated with a sealant to inhibit/prolong decay.

- c. Once the upstream and downstream slopes are clear of woody vegetation, the slope should be inspected by your PE to determine if slides and/or benching are occurring. Proper repairs to these problems should be developed and implemented under the supervision of a PE. After tree removal, a proper grass cover should be reestablished.

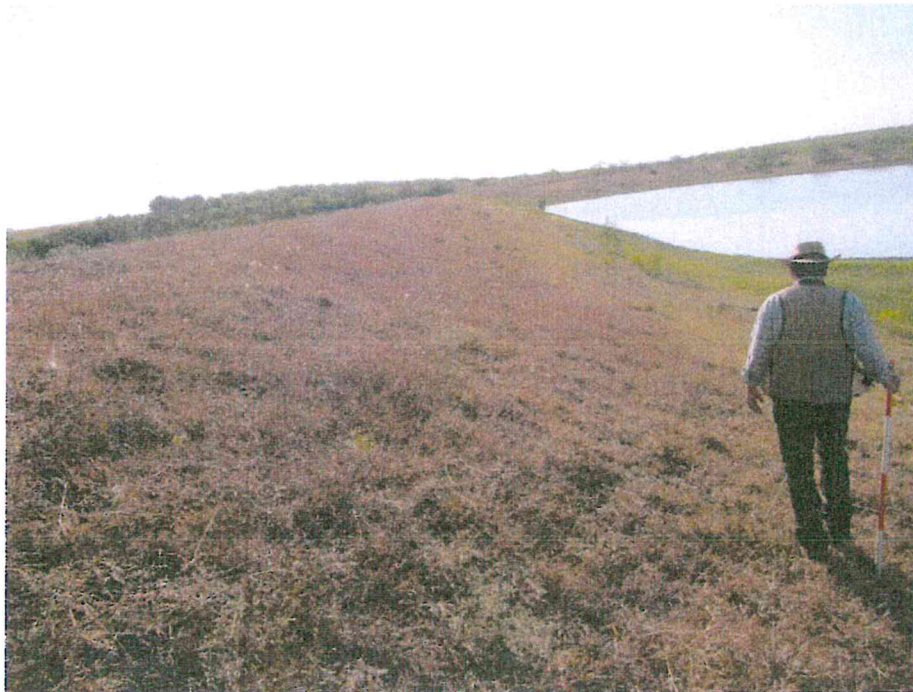
Photograph 4. Upstream slope looking right.

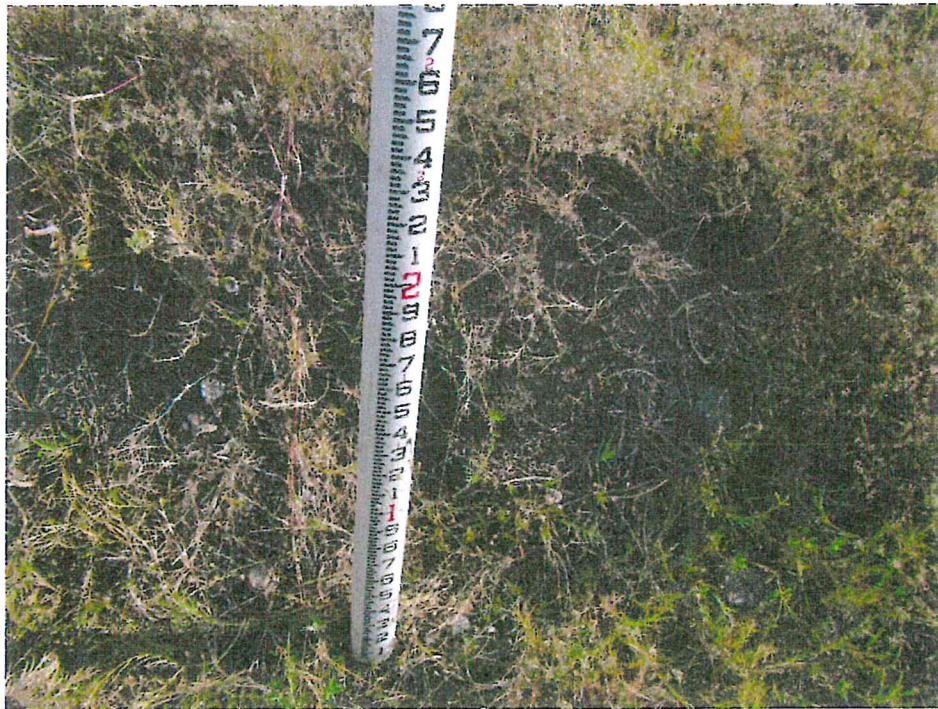
Photograph 5. Upstream slope with minor benching.

- b. Monitor on a regular basis the benching on the upstream slope until repairs are made.
  - c. Monitor on a regular basis the erosion at the emergency spillway exit until repairs are made

5. It is recommended that some form of erosion protection be installed on the upstream slope to combat wave-action erosion, such as rock riprap or an equivalent. Due to the level of benching and steepness of the slope, it may be necessary to rebuild/regrade the slope prior to installing the protection. A PE should design the needed repairs/improvements and have related construction plans reviewed and approved by TCEQ Dam Safety.

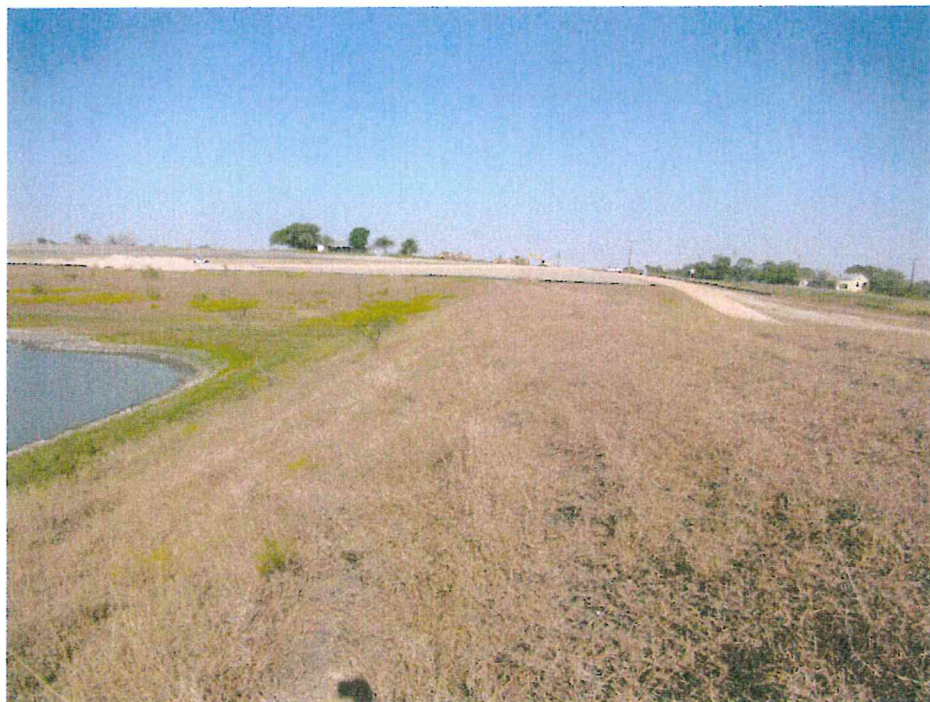
Photograph 6. Upstream slope looking left.

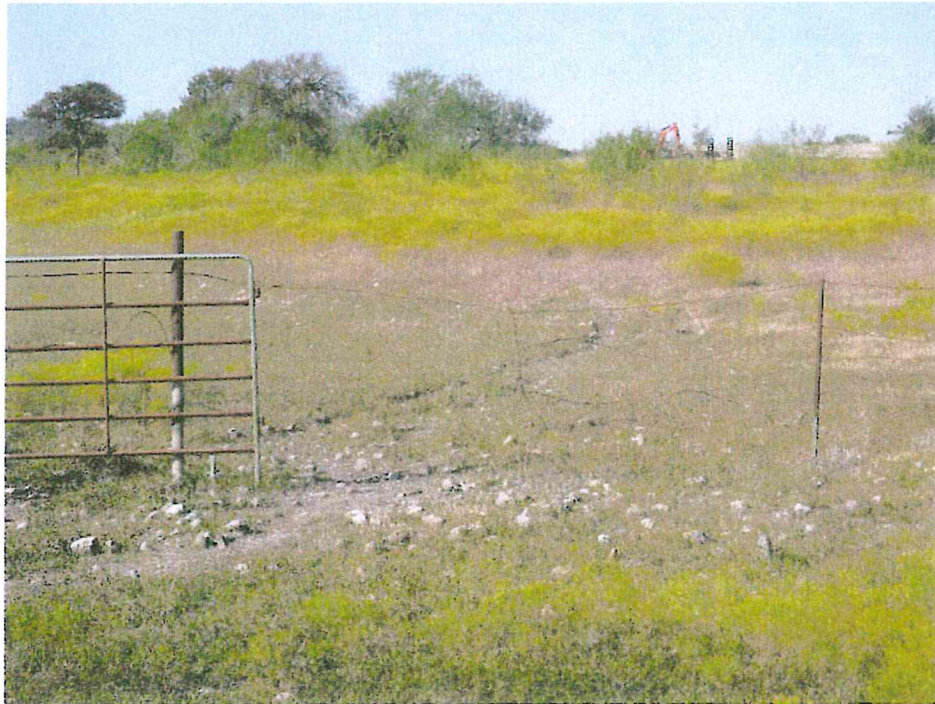
Photograph 7. Hole in fence north of left end of dam.

- e. Livestock access should be restricted, or at a minimum controlled, to prevent erosion, benching, overgrazing, etc. The livestock trails on the embankment can lead to erosion and loss of embankment materials. Consideration should be given to installing a fence to restrict access of livestock, the trailing should be repaired, and vegetation allowed to regrow.

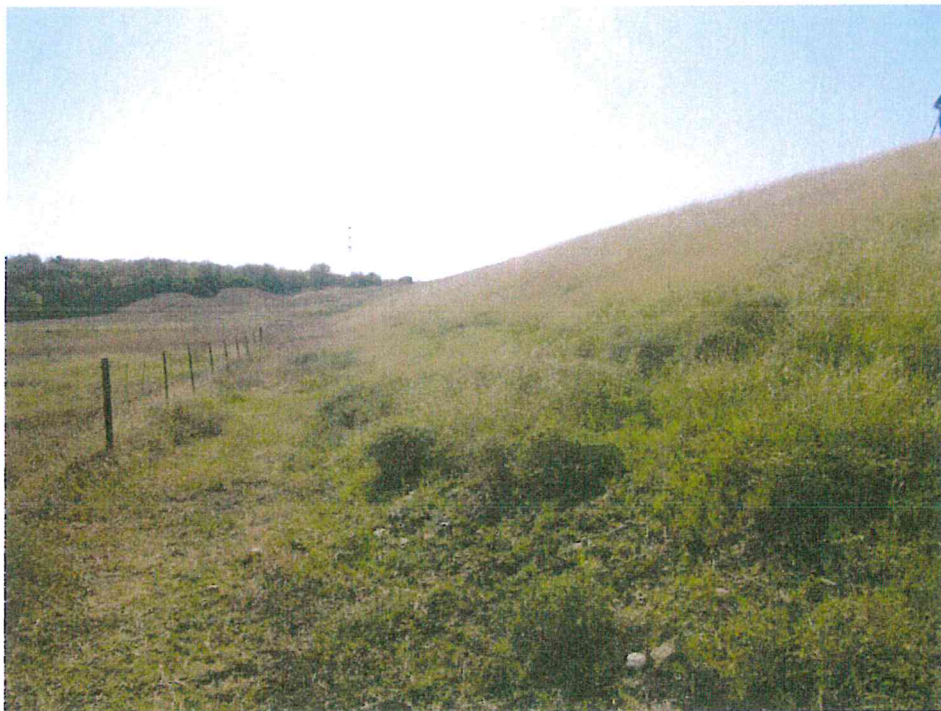
- The 2.5H:1V downstream slope of the earthen embankment was covered mostly with grass and contained several saplings.
- The downstream slope was found to be in fair condition.
- See photographs 7, 8 and 9.

Photograph 8. Downstream slope looking right.

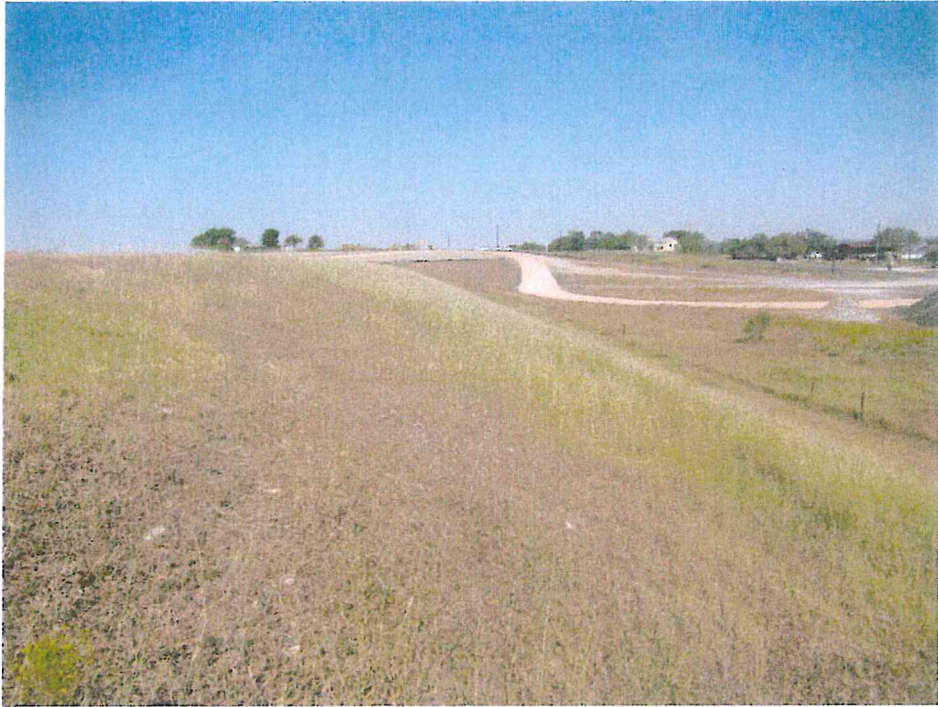
Photograph 9. Downstream slope looking left.

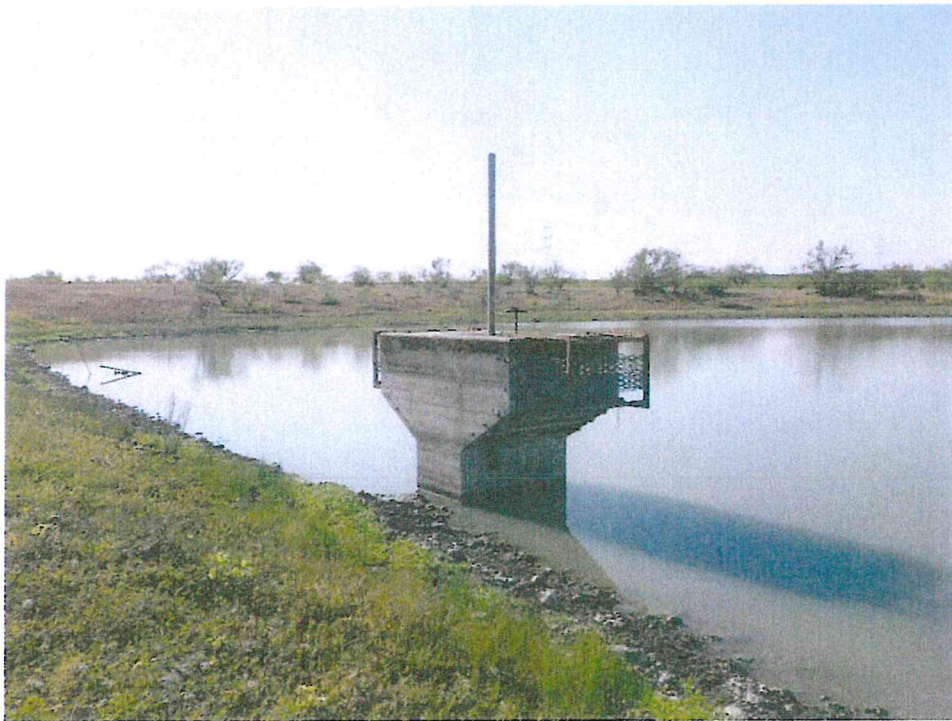
- The principal spillway, a drop inlet type with a 24-inch diameter outlet pipe, is located approximately 895 feet from the left end of the dam.
- The trash racks were clean, however, there was minor rust on metal surfaces.
- The outlet pipe had spalling and contained a small amount of water. The 2017 inspection report noted the outlet pipe spalling and a drainage issue with the plunge pool. The reservoir level during the current inspection was relatively low (542.2 ft-msl) when compared to the level during the 2017 inspection (546.2 ft-msl) so there was no evidence of a drainage issue, however, the pipe did contain a small amount of water which may be indicative of a drainage issue.
- The principal spillway was found to be in fair condition.
- See photographs 10, 11, 12 and 13.

Photograph 10. Principal Spillway inlet.

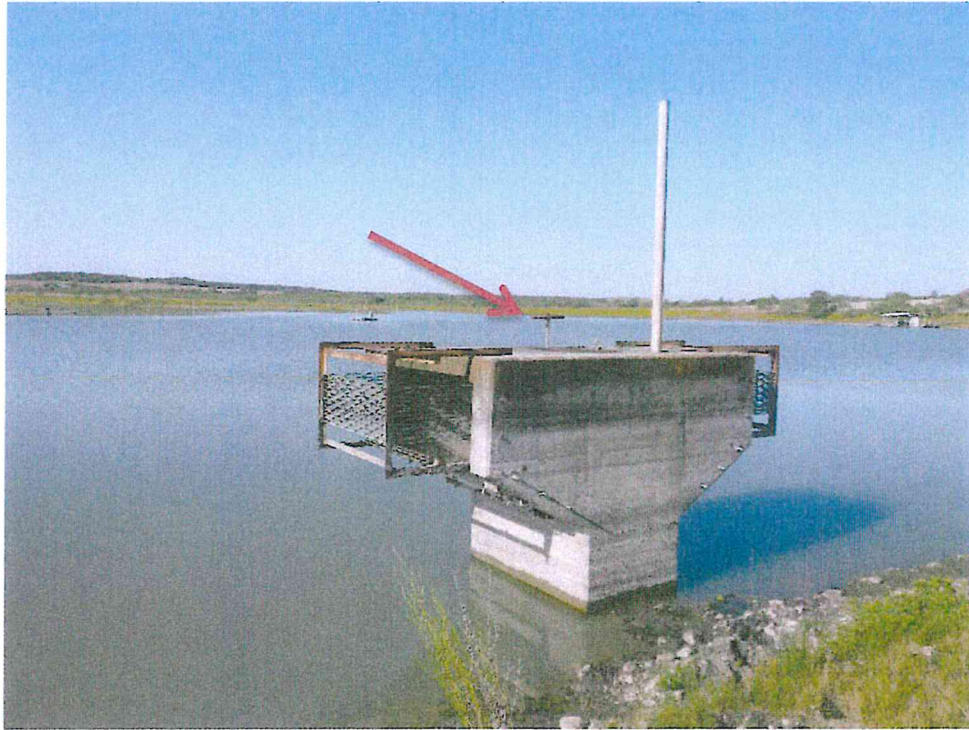
- The principal inlet is equipped with a low flow outlet valve that is inspected and maintained by Performance Plus Inc. per Beverly Hartwick, Administrative Secretary for the York Creek Board.
- The valve was last exercised in 2023.
- The low flow outlet was found to be in fair condition.
- See photograph 11.

Photograph 11. Principal Spillway inlet and Low Flow valve.

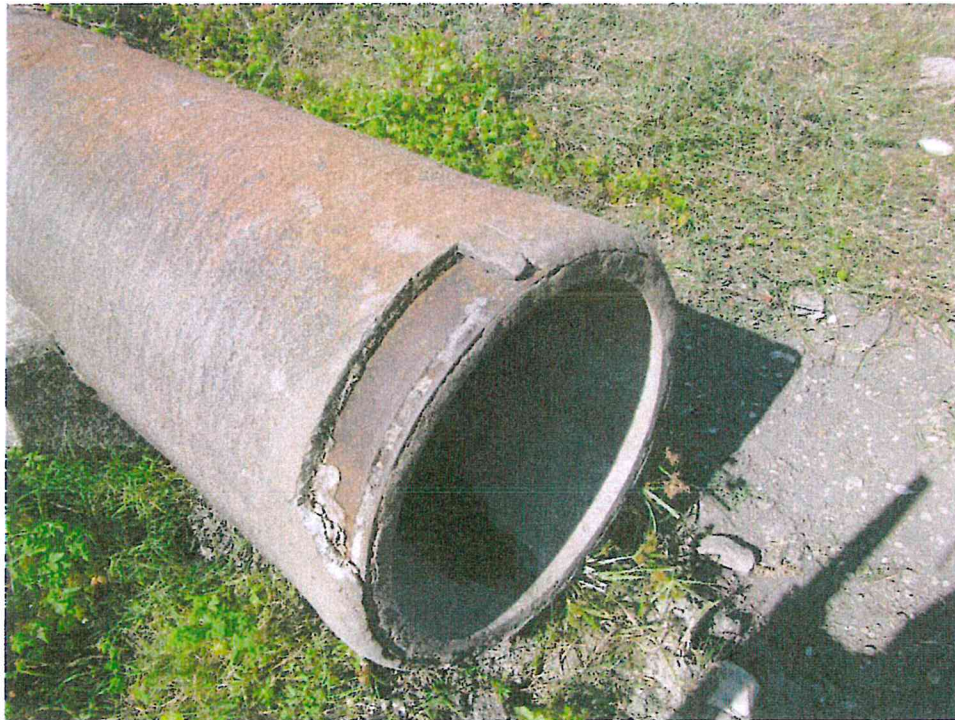
Photograph 12. Principal Spillway discharge outlet with spalling.

- d. Monitor on a regular basis the spalling on the principal spillway outlet pipe until repairs are made.

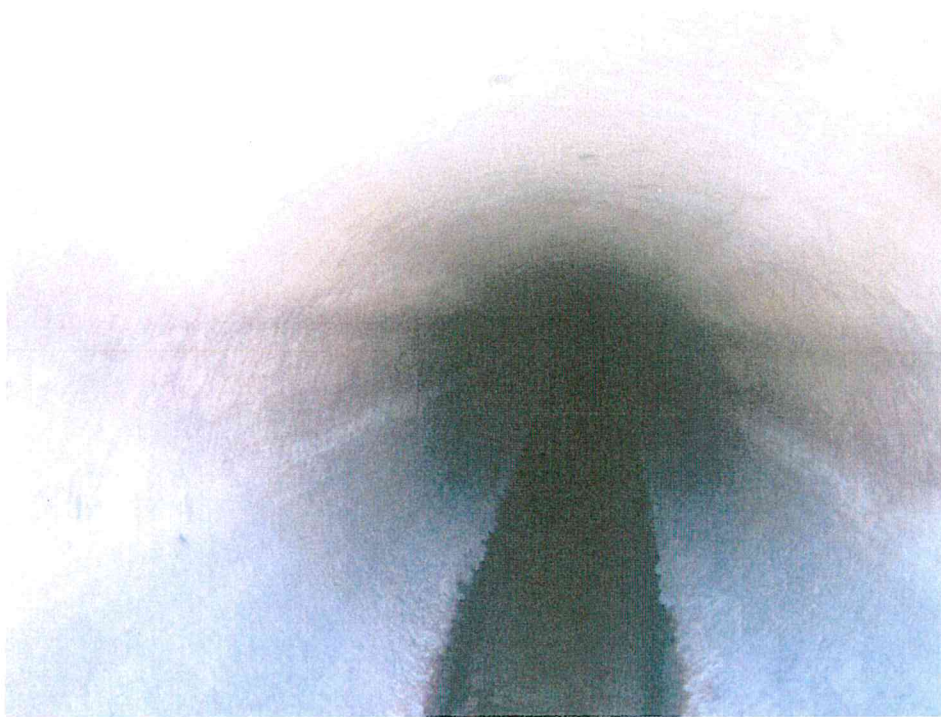
Photograph 13. Principal Spillway discharge outlet with standing water.

7. Determine the cause of the poor drainage at the spillway outlet's stilling basin, and remedy so that the ponded water drains properly. Once positive drainage has been established, the area should be inspected for any additional deficiencies that may have been hidden by the submerged condition. Having the outlet pipes exposed and the stilling basin dewatered is important as it maximizes the spillway and discharge channel's conveyance, as well as allows a proper inspection of the outlet area, where many incipient problems can first be detected.

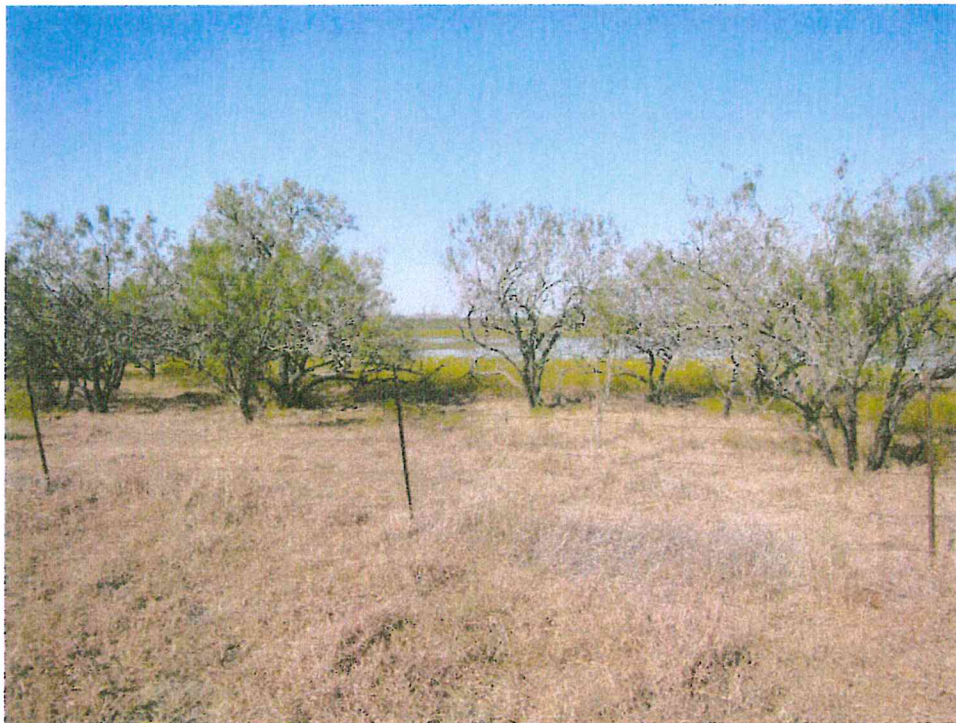
- The emergency spillway, located at the right (east) side of the dam, was covered with mostly grass and small weed. Per the NRCS as-built plans, the spillway is a 100 ft wide earthen channel.
- Trees and a fence were observed, upstream of the control section, at the entrance to the emergency spillway.
- Minor gully erosion was observed at the end of the emergency spillway.
- The emergency spillway was found to be in fair condition.
- See photographs 14, 15 and 16.

Photograph 14. Emergency spillway inlet. Note trees and fence at inlet.

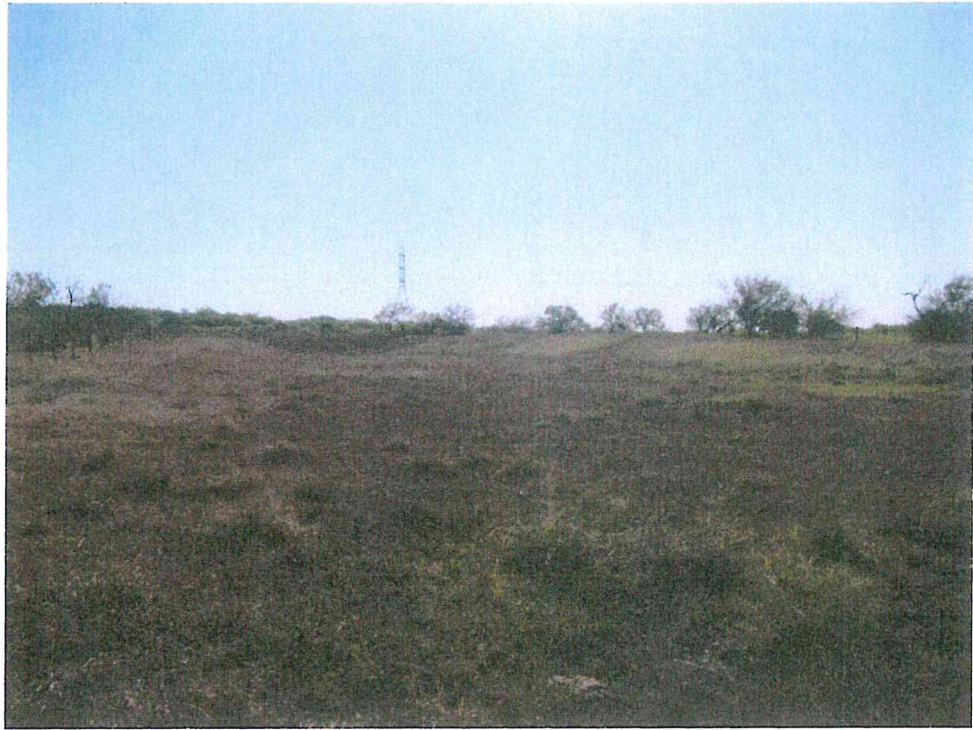
Photograph 15. Emergency spillway.

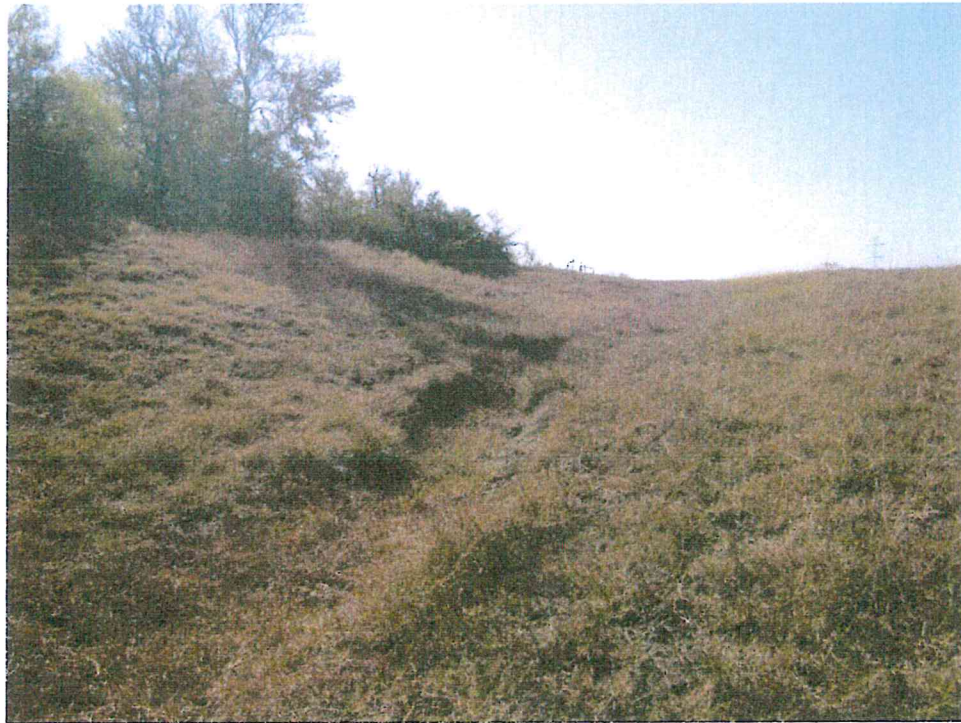
6. Repair erosion channels or gullies (and determine cause if unknown or if new occurrence). Erosion was observed at the emergency spillway outlet.

Photograph 16. Emergency spillway outlet. Note erosion.

- b. Establish a good grass cover in repaired areas.
  - c. Erosion around inlets and along conduits may require a PE to determine the problem and recommend a correction.

- d. Until repairs are implemented, the eroded areas in the spillway and discharge channel should be routinely monitored for further erosion, especially after spillway engagements. If the erosion worsens significantly, the reservoir may need to be lowered or drained to prevent an emergency situation from developing.

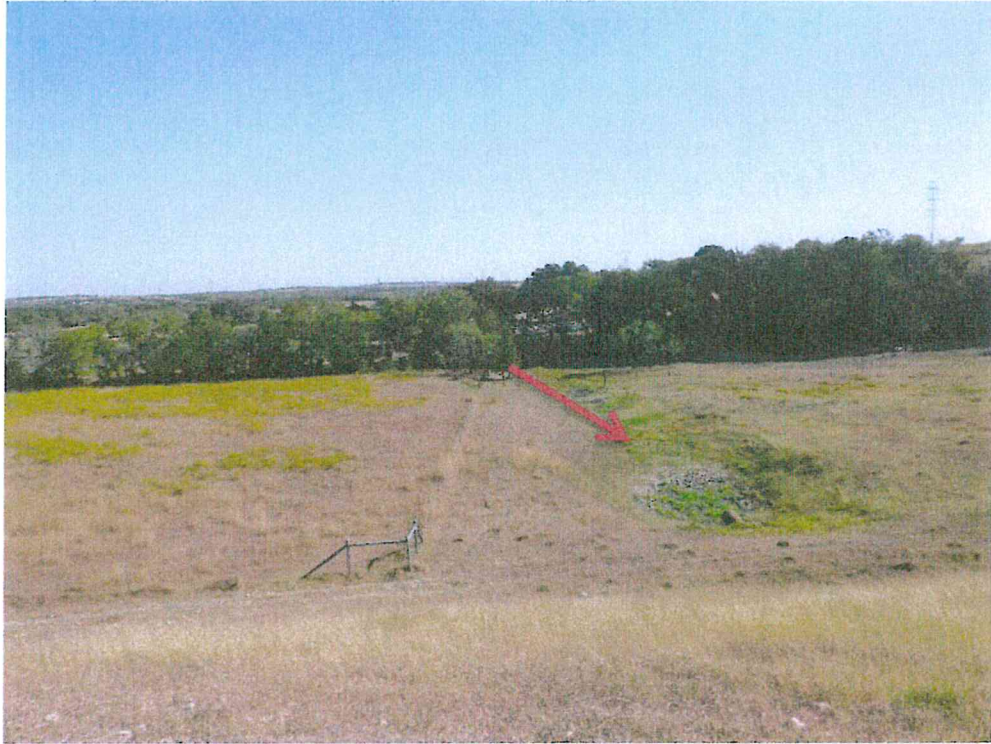
- Vegetation was noted that has the potential to restrict the conveyance of water.
- The discharge channel was found to be in fair condition.
- See photographs 17 and 18.

Photograph 17. Plunge pool and discharge channel.

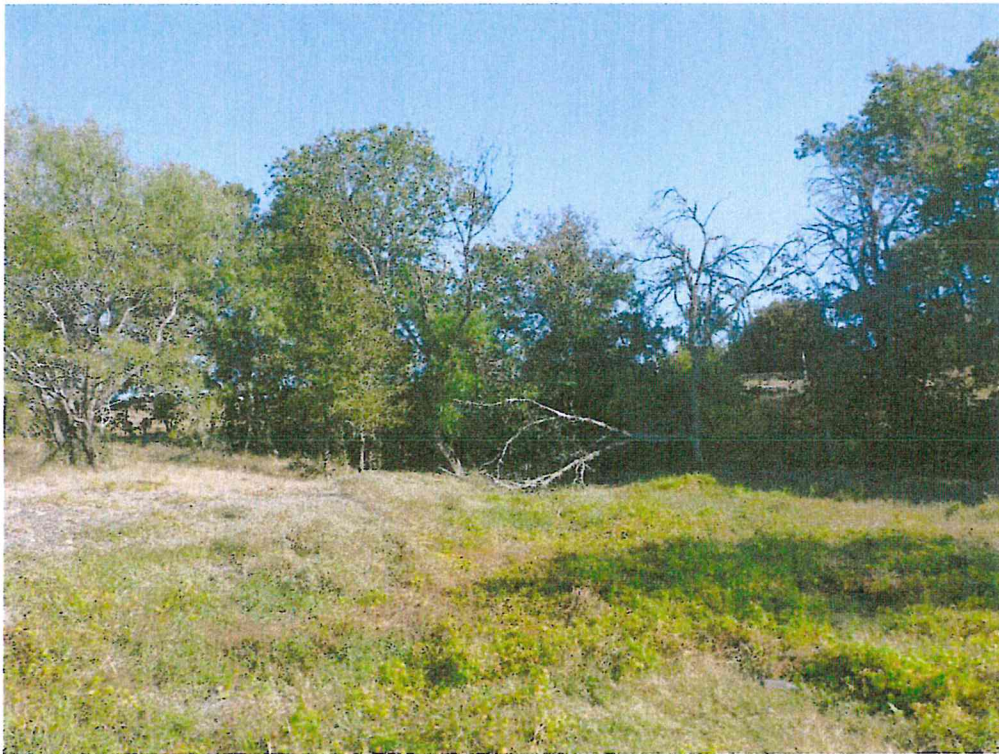
Photograph 18. Discharge channel.

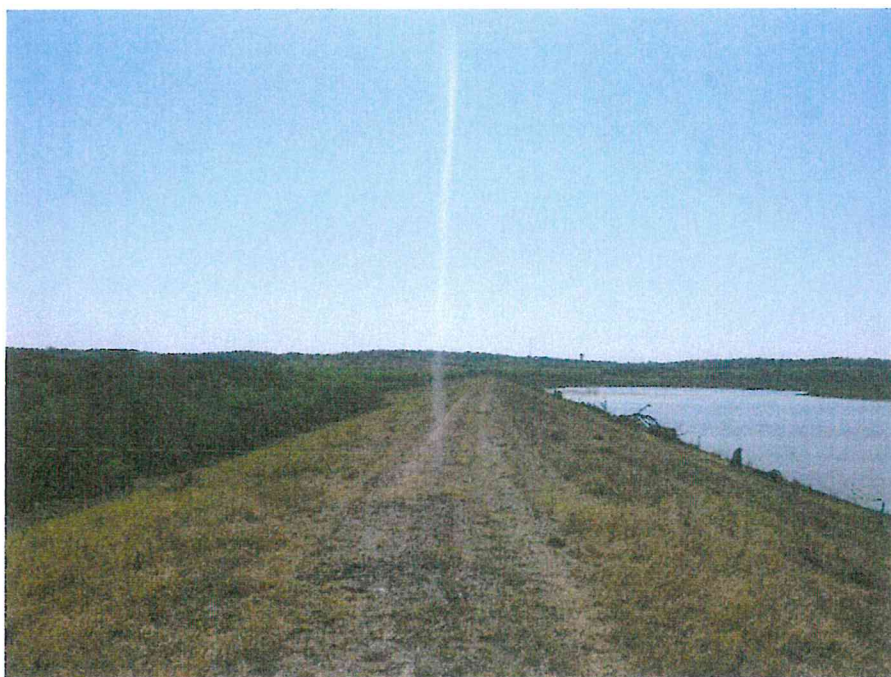
- The 14-foot wide crest of the dam was mainly level with good grass coverage, however, bare spots were noted due vehicle and animal traffic at the left end of the dam.
- The crest was found to be in good condition.
- See photographs 1 and 2.

Photograph 1. Crest looking right. Note rutting and bare spots.

- a. Monitor on a regular basis the bare spots and rutting on the crest until a grazing plan is implemented and repairs are made.
  - b. Monitor on a regular basis the benching on the upstream slope until repairs are made.

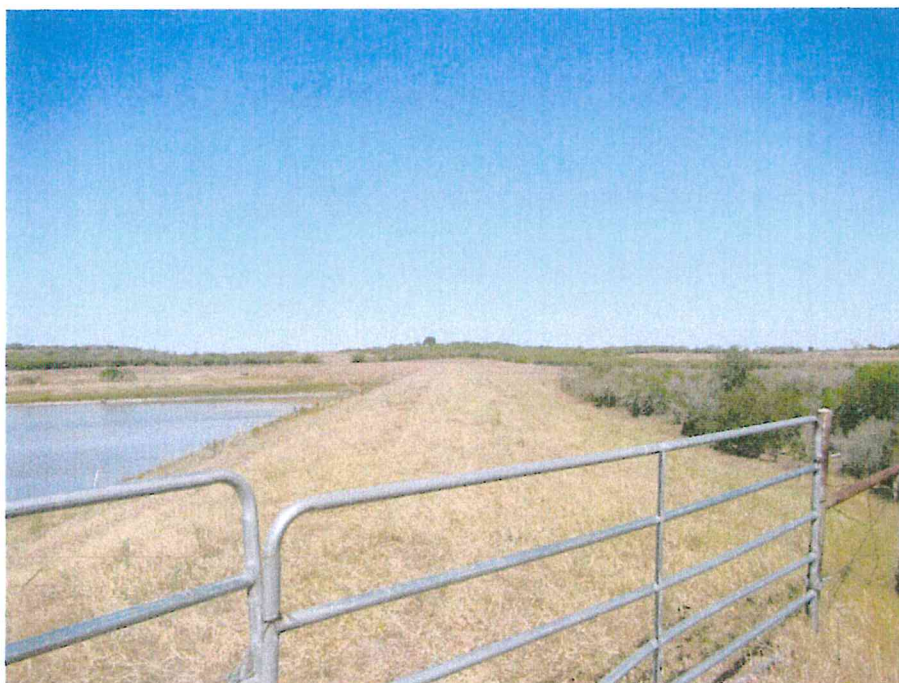
Photograph 2. Crest looking left.

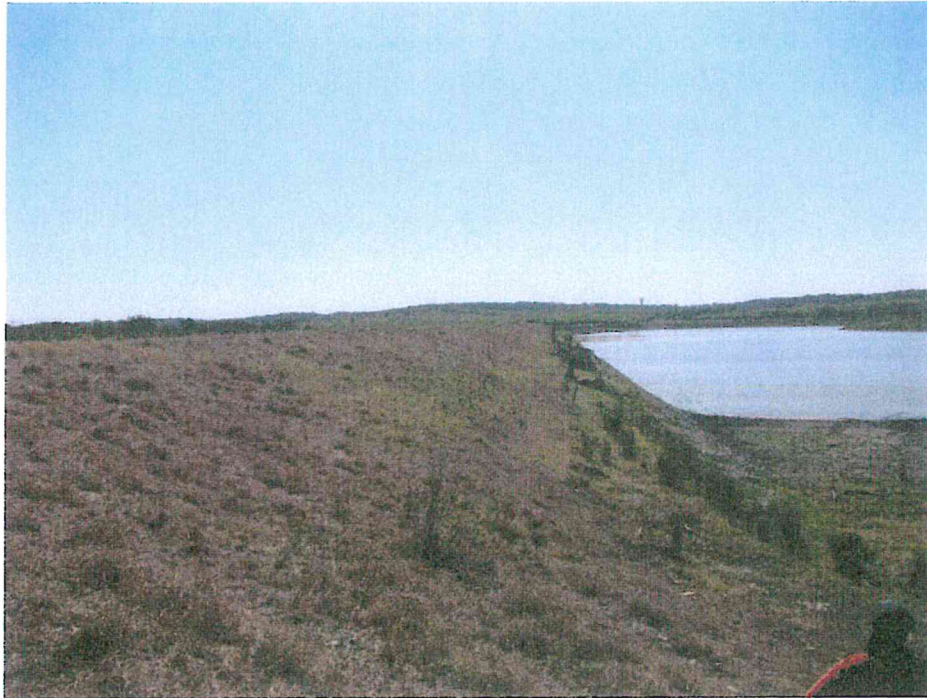
- The 2.5 horizontal to 1 vertical [2.5H:1V] upstream slope of the earthen embankment contained several large dead trees, small animal burrows, and is experiencing minor benching.
- Riprap with weeds were observed at the bottom of the upstream slope. Some riprap was displaced by wave action.
- The fence at the left end of the upstream slope is falling down.
- The upstream slope was found to be in fair condition.
- See photographs 3, 4, 5, and 6.

Photograph 3. Upstream slope looking right with saplings.

- b. For any larger/mature trees immediately adjacent to conduits and/or concrete structures (headwall, training walls, etc.), it may be preferred to cut the tree and leave the stump in place, if removal of the rootball would cause damage/movement to the conduit, concrete, etc. Any remaining stump(s) should be treated with a sealant to inhibit/prolong decay.

- c. Once the upstream and downstream slopes are clear of woody vegetation, the slope should be inspected by your PE to determine if slides and/or benching are occurring. Proper repairs to these problems should be developed and implemented under the supervision of a PE. After tree removal, a proper grass cover should be reestablished.

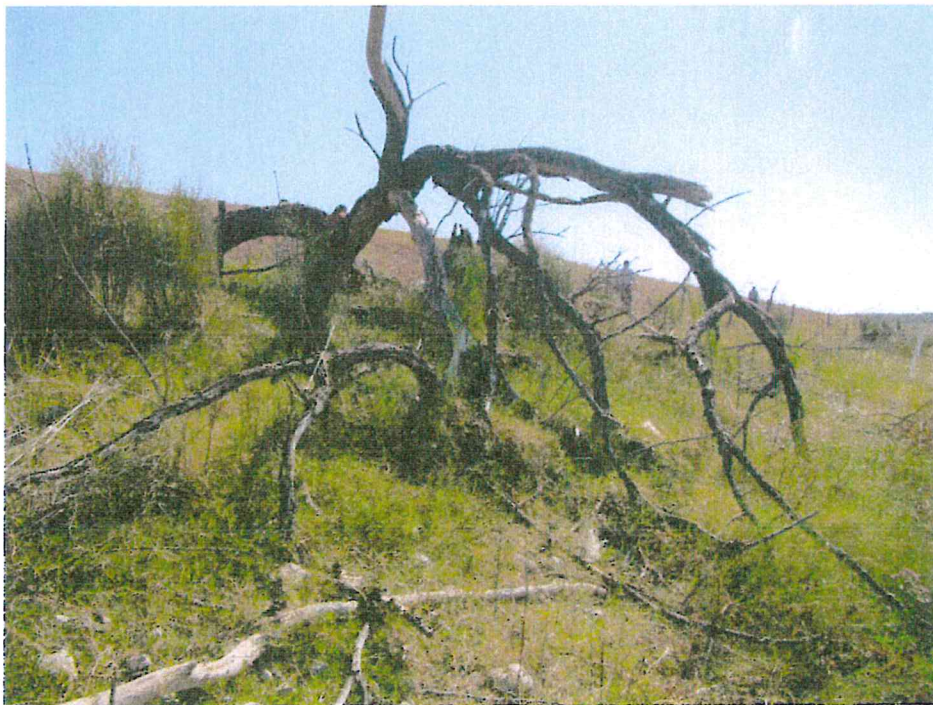
Photograph 4. Upstream slope looking right. Note woody debris.

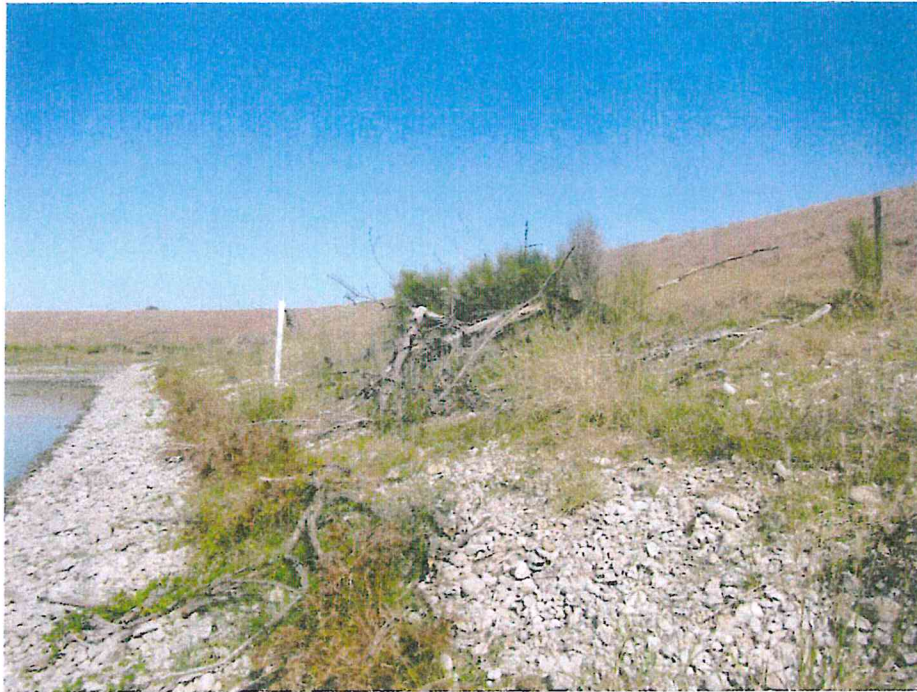
Photograph 5. Upstream slope looking left with dead trees and displaced riprap.

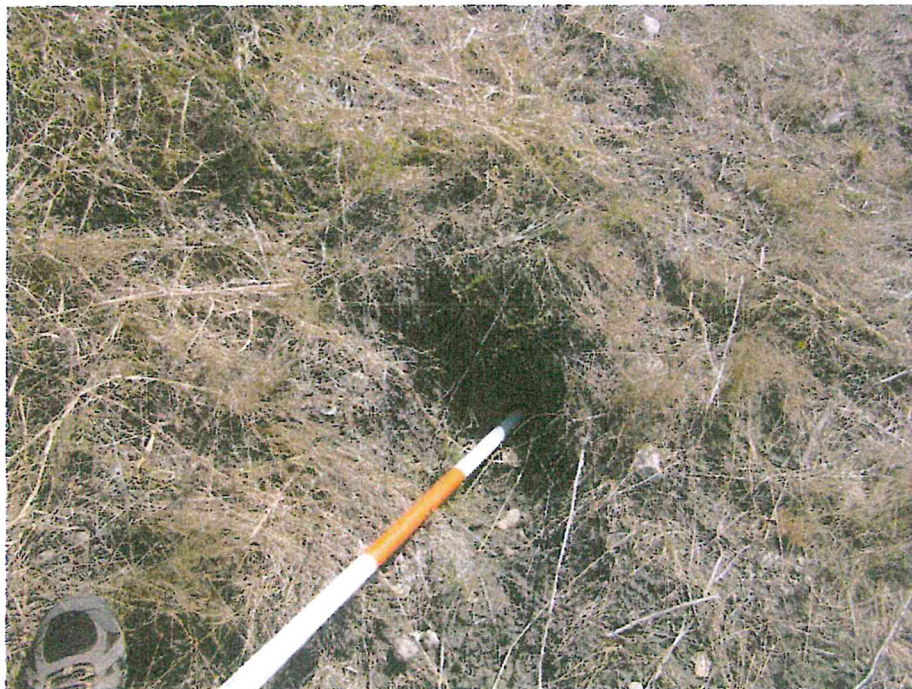
Photograph 6. Upstream slope with burrow.

5. The noted animal burrows should be backfilled with properly compacted non-dispersive clay, and a vegetative cover should be established. Burrowing activity can create flow paths and can otherwise weaken the integrity of the embankment. Assistance in removing nuisance animals can be obtained from the Texas Wildlife Services Program. Burrowing animals should be discouraged from inhabiting the dam.

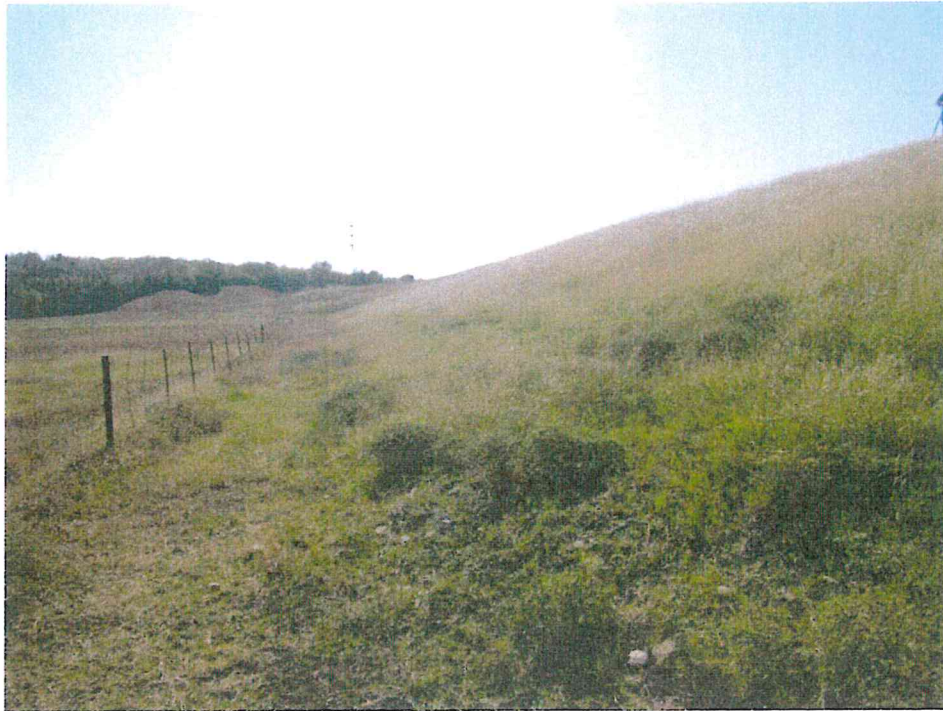
- The 2.5H:1V downstream slope of the earthen embankment was covered mostly with grass and some Greenbriar at right end of dam.
- The downstream slope was found to be in good condition.
- See photographs 7 and 8.

Photograph 7. Downstream slope looking right.

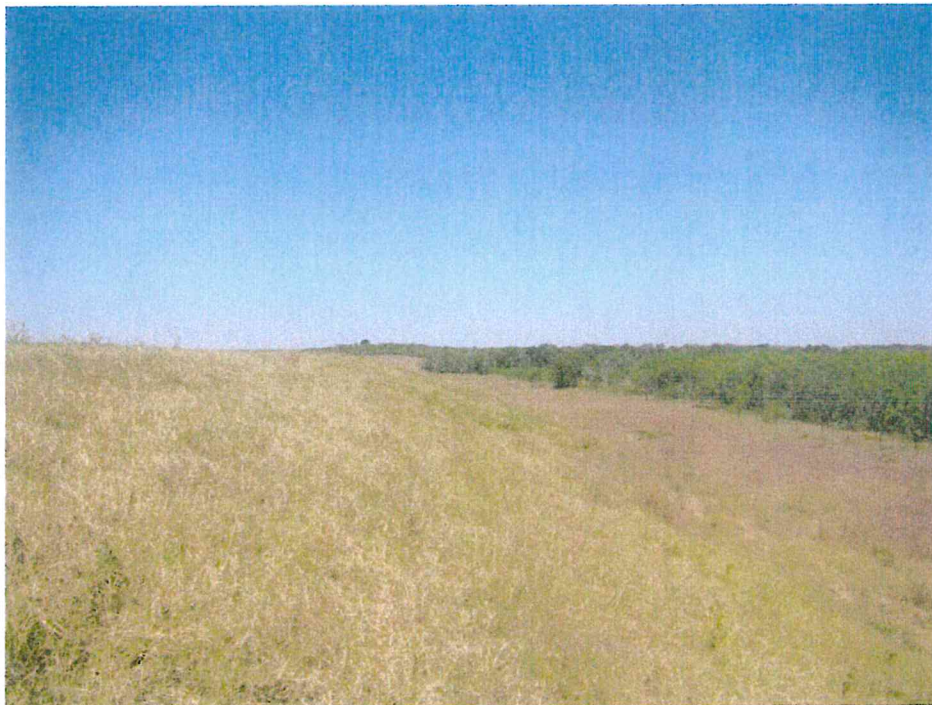
Photograph 8. Downstream slope looking left.

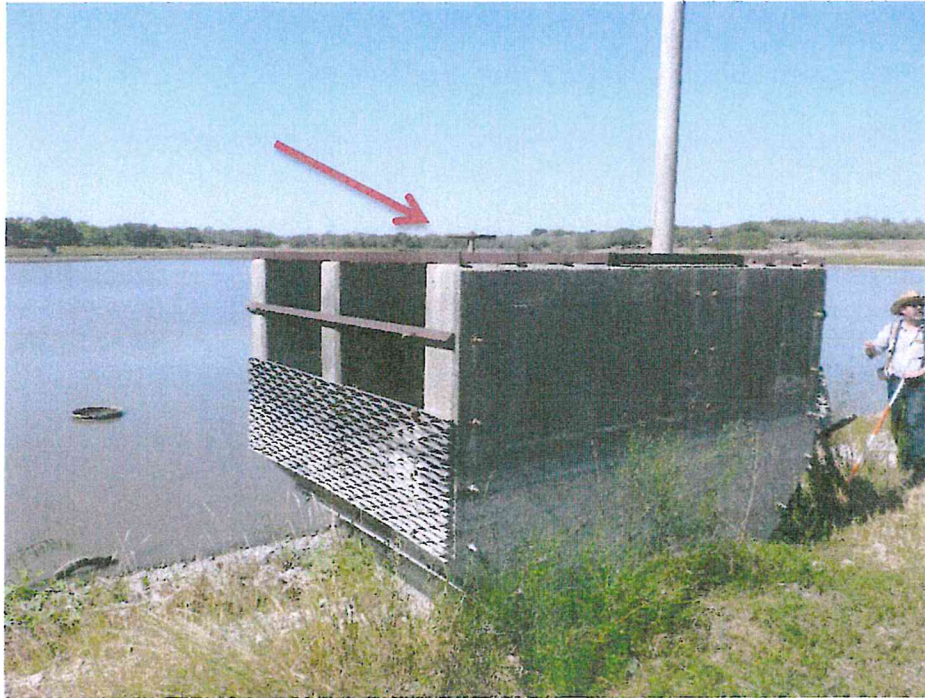
- The principal spillway, a drop inlet type with an orifice plate, is located approximately 800 feet from the left abutment.
- The 24-inch diameter outlet pipe had minor spalling.
- The trash racks were clean, however, there was minor rust on metal surfaces.
- The principal spillway was found to be in good condition.
- See photographs 9, 13 and 14.

- The principal inlet is equipped with a low flow outlet valve that is inspected and maintained by Performance Plus Inc. per Beverly Hartwick, Administrative Secretary for the York Creek Board.
- The low flow outlet was found to be in fair condition.
- See photograph 9.

Photograph 9. Principal Spillway inlet and Low Flow valve.

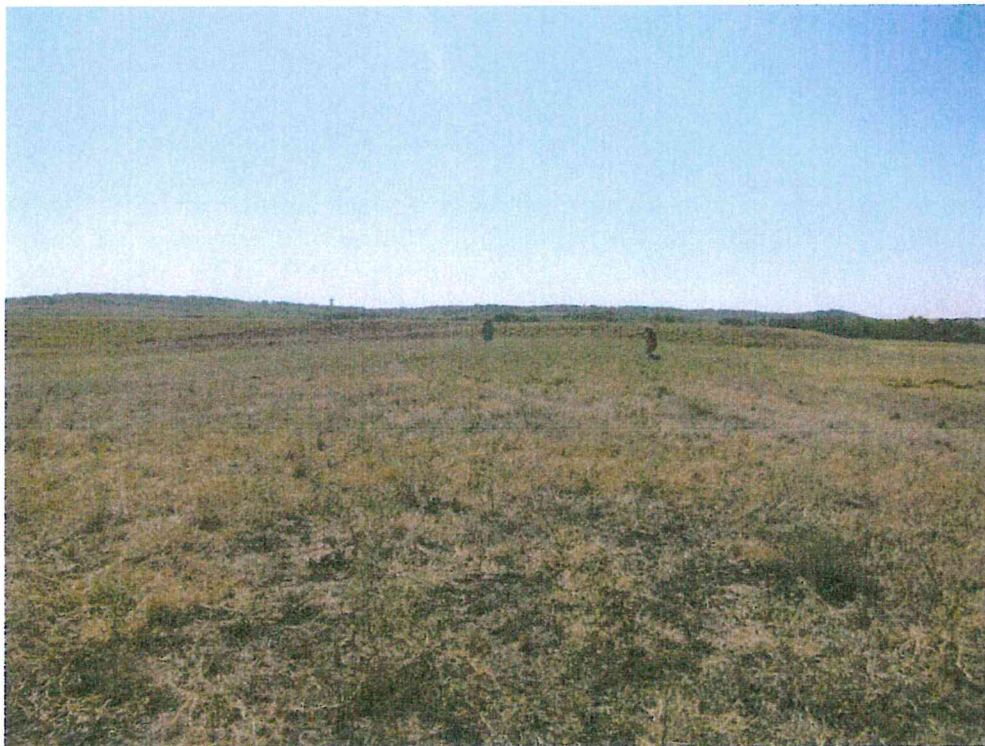
- The emergency spillway, located at the left side of the dam, was covered with mostly grass and small weed cover. Per the NRCS as-built plans, the spillway is a 300 ft wide earthen channel. The control elevation was measured to be 5.8 feet below the emergency spillway crest, or 529.5 ft-msl.
- Erosion was observed at the northwest crest of the spillway.
- The emergency spillway was found to be in fair condition.
- See photographs 10, 11 and 12.

Photograph 10. Emergency spillway.

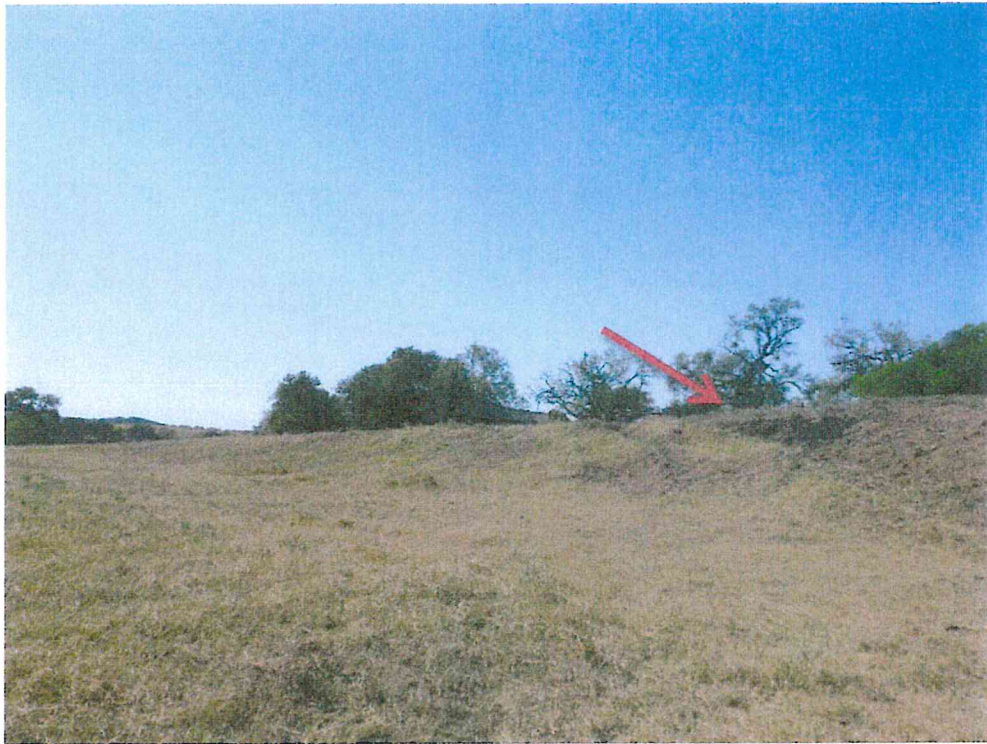
6. Repair erosion channels or gullies (and determine cause if unknown or if new occurrence). Erosion was observed at the northwest crest of the emergency spillway.

Photograph 11. Emergency spillway northwest crest. Note erosion.

- b. Establish a good grass cover in repaired areas.
  - c. Erosion around inlets and along conduits may require a PE to determine the problem and recommend a correction.
