Subject: Dam Safety Inspection Reports  
York Creek WS SCS Site 6 Dam – TX01605  
York Creek WS SCS Site 11 Dam – TX01603

### **DAM SAFETY INSPECTION REPORT**

INVENTORY No.: TX01605

DAM: York Creek WS SCS Site 6 Dam

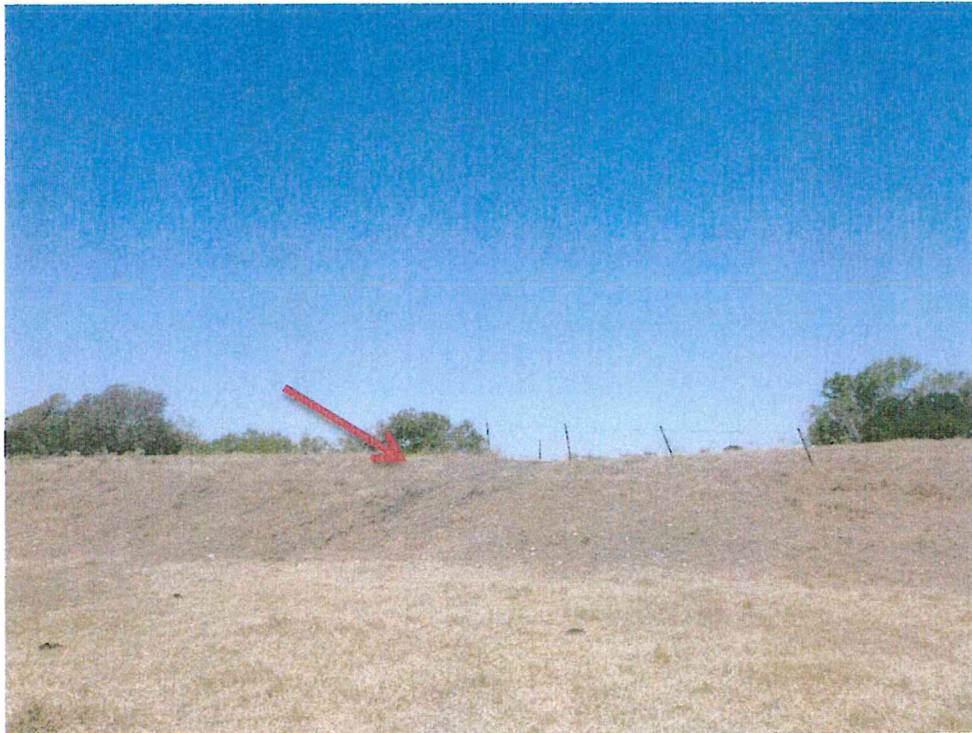
- The emergency spillway, located at the left side of the dam, was covered with mostly grass and small weed cover. Per the NRCS as-built plans, the spillway is a 300 ft wide earthen channel. The control elevation was measured to be 5.8 feet below the emergency spillway crest, or 529.5 ft-msl.
- Erosion was observed at the northwest crest of the spillway.
- The emergency spillway was found to be in fair condition.
- See photographs 10, 11 and 12.

6. Repair erosion channels or gullies (and determine cause if unknown or if new occurrence). Erosion was observed at the northwest crest of the emergency spillway.

Photograph 12. Emergency spillway northwest crest. Note erosion and damaged fence.

- b. Establish a good grass cover in repaired areas.
  - c. Erosion around inlets and along conduits may require a PE to determine the problem and recommend a correction.

- d. Livestock access should be restricted, or at a minimum controlled, to prevent erosion, benching, overgrazing, etc. The livestock trails on the embankment can lead to erosion and loss of embankment materials. Consideration should be given to installing a fence to restrict access of livestock, the trailing should be repaired, and vegetation allowed to regrow.

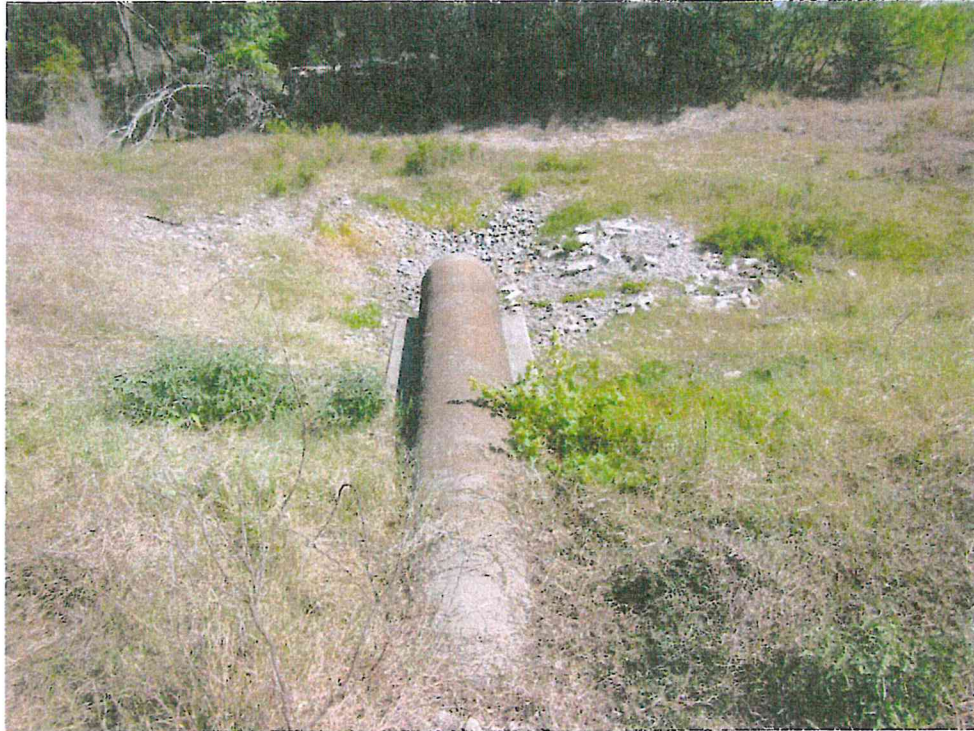
- The principal spillway, a drop inlet type with an orifice plate, is located approximately 800 feet from the left abutment.
- The 24-inch diameter outlet pipe had minor spalling.
- The trash racks were clean, however, there was minor rust on metal surfaces.
- The principal spillway was found to be in good condition.
- See photographs 9, 13 and 14.

Photograph 13. Principal Spillway discharge outlet and plunge pool.

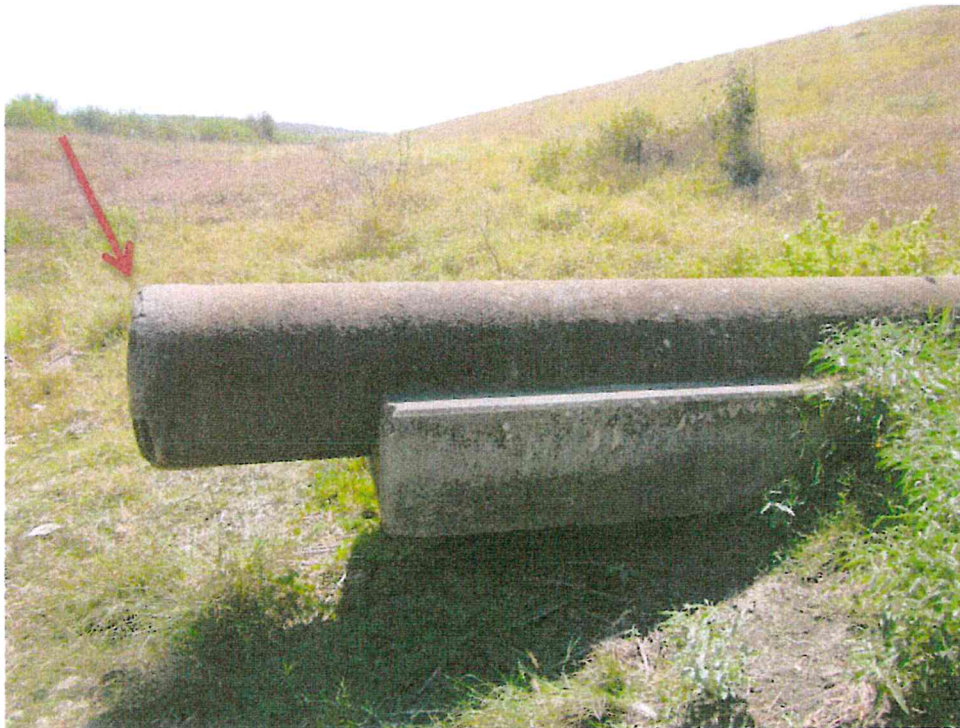
Photograph 14. Principal Spillway discharge outlet with spalling.

- c. Monitor on a regular basis the erosion at the emergency spillway exit until repairs are made.
- d. Monitor on a regular basis the spalling on the principal spillway outlet pipe until repairs are made.

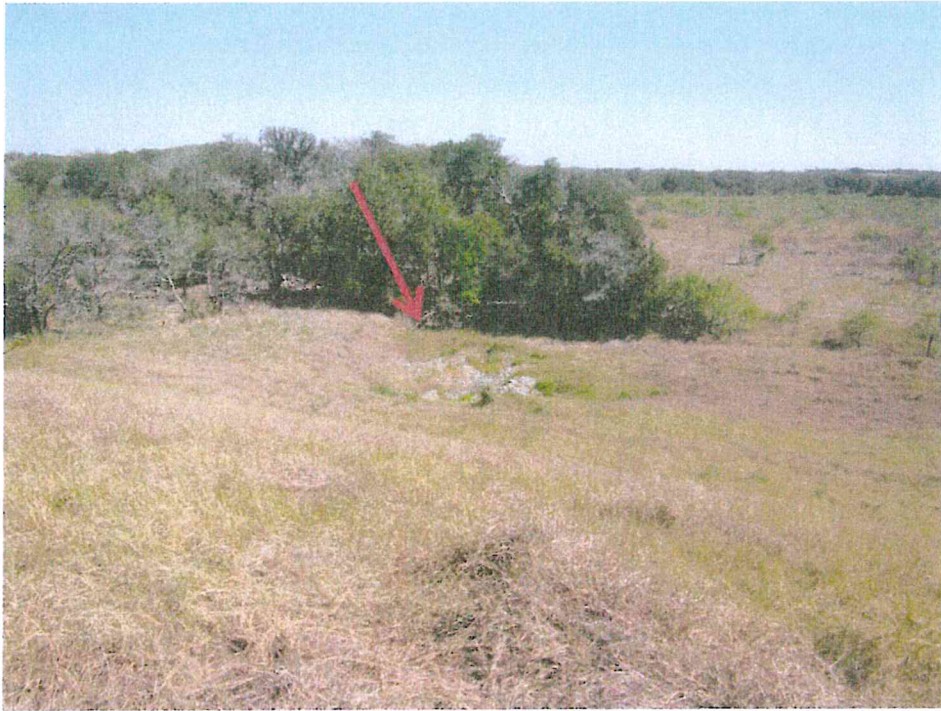
- Vegetation and trees were observed within 50 feet of the outlet that has the potential to restrict the conveyance of water.
- The discharge channel was found to be in fair condition.
- See photograph 15.

Photograph 15. Discharge channel. Note trees in channel.
